## Ten Year Retrospective Look at HRSG FAC Assessment and Incidence

*Peter S. Jackson, PhD, PE, David S. Moelling, PE, Mark Taylor, Mech. Eng.*

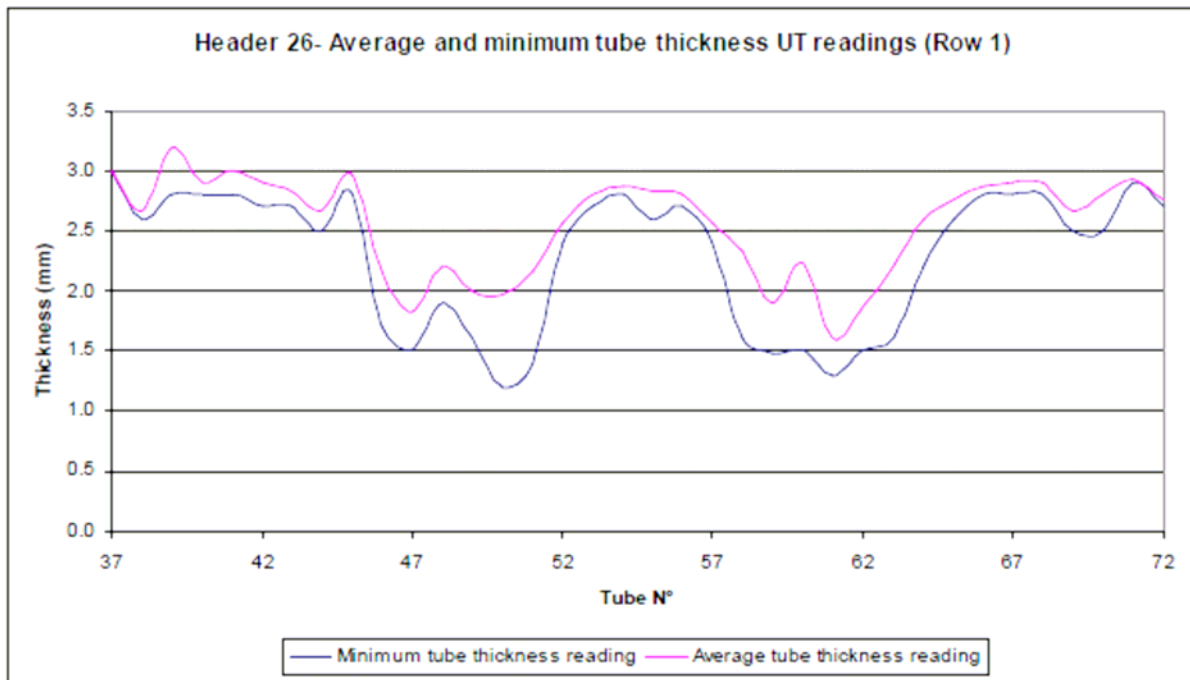
Figure 3 - FAC Damage in Lower LP Header Area

At a large horizontal gas path HRSG, extensive FAC damage was found at riser piping to the lower headers from the downcomer manifolds and just at the tube to header weld above these risers. The plant had high duct firing capability and steam production was very high. The damage occurred only in the leading LP Evaporator panels with the highest heat input (flow rates). FAC damage was not present only a short distance away from the header at the lower bends. Figure 2 shows the arrangement.

Figure 3 shows the observed wear in one half of the LP Evaporator (two modules wide). The peak wear is directly above the riser piping and decreases as you move away. Not shown in the figure is that the location of peak wear on the tube was away from the source of fluid flow. This indicated that the local turbulence was caused by the flow impacting on the side of the tube/header orifice.

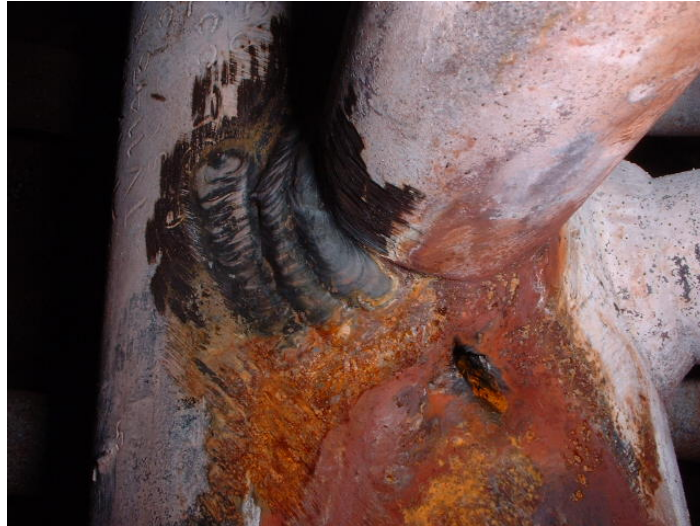
Figure 4 - FAC Damage to Header

This example is of a vertical gas path HRSG with local damage to the header and tube of the LP Evaporator section. Figures 4 and 5 show FAC damage to the header and tube bends.

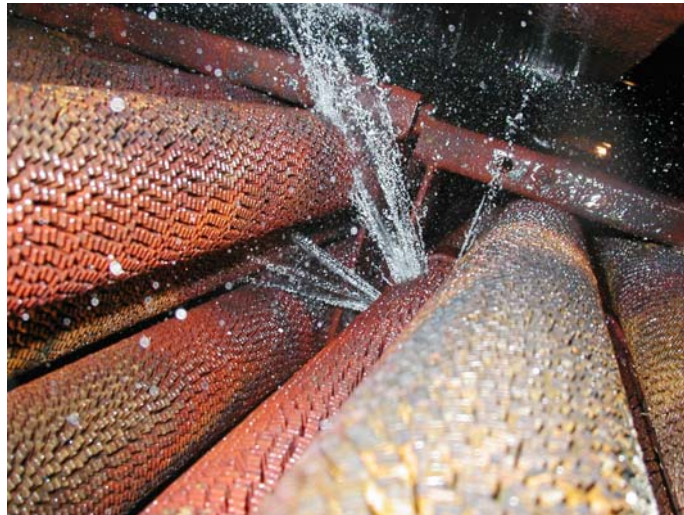
Figure 6 - FAC leak in Tube Mid-Span

Another example of isolated FAC damage is where a rare mid-span tube leak occurred. (Figure 6). The cause was found to be local turbulence cause by a poor weld joining two lengths of tube.
