## Ten Year Retrospective Look at HRSG FAC Assessment and Incidence

*Peter S. Jackson, PhD, PE, David S. Moelling, PE, Mark Taylor, Mech. Eng.*

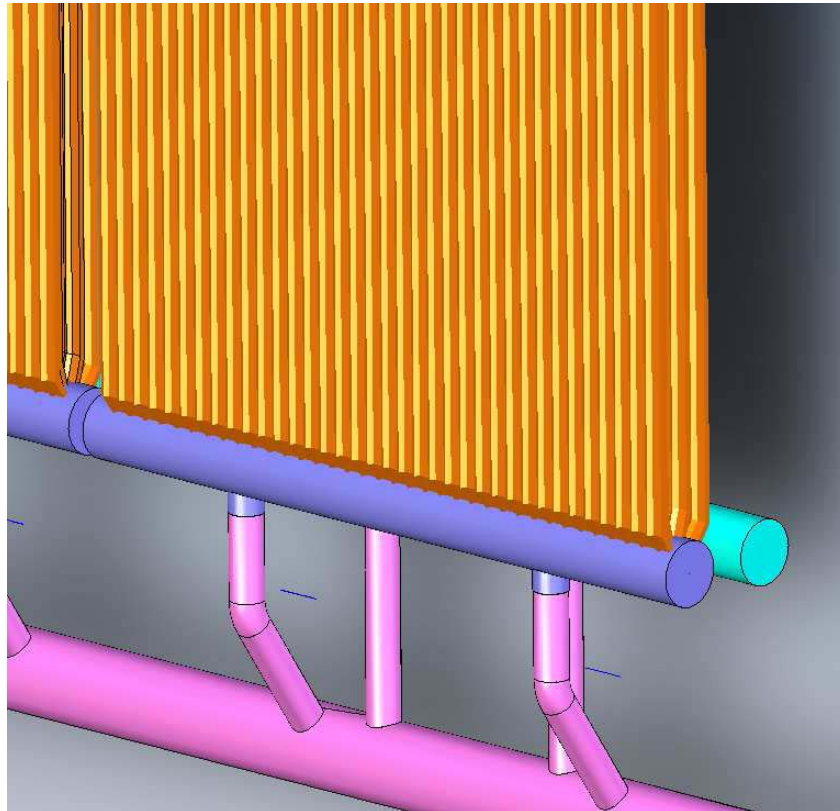
Figure 2 - LP Evaporator Arrangement

At a large horizontal gas path HRSG, extensive FAC damage was found at riser piping to the lower headers from the downcomer manifolds and just at the tube to header weld above these risers. The plant had high duct firing capability and steam production was very high. The damage occurred only in the leading LP Evaporator panels with the highest heat input (flow rates). FAC damage was not present only a short distance away from the header at the lower bends. Figure 2 shows the arrangement.
